# Floating Knee And Patellar Fracture: A Case Report

A Megharzi , K Moudjari , A Rassouli , F Meziani , A Benhabiles .  
Department of orthopaedic surgery and traumatology /A CHU Constantine  
Laboratoire de recherche MaGAL  
Faculté de Médecine Université de Constantine 3 Salah Bubonider

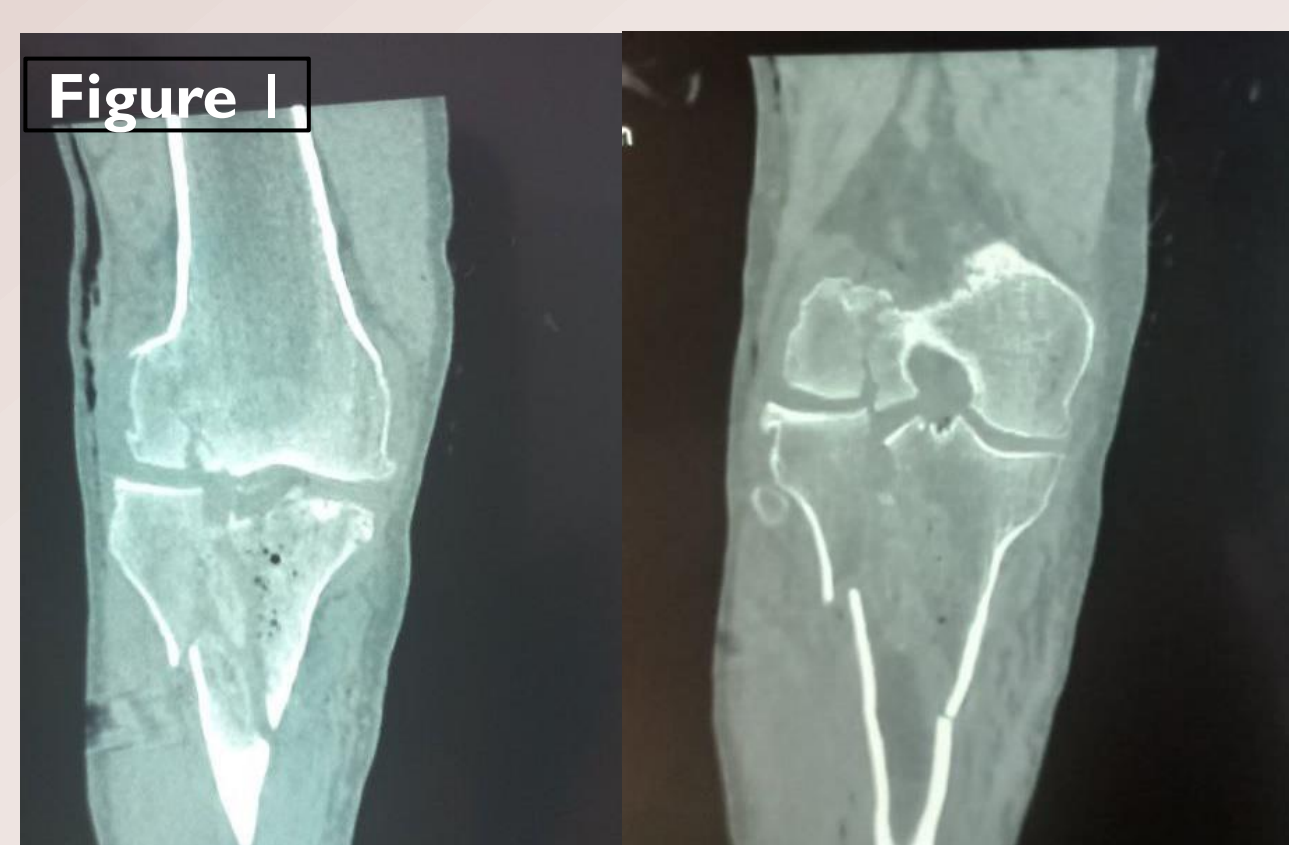
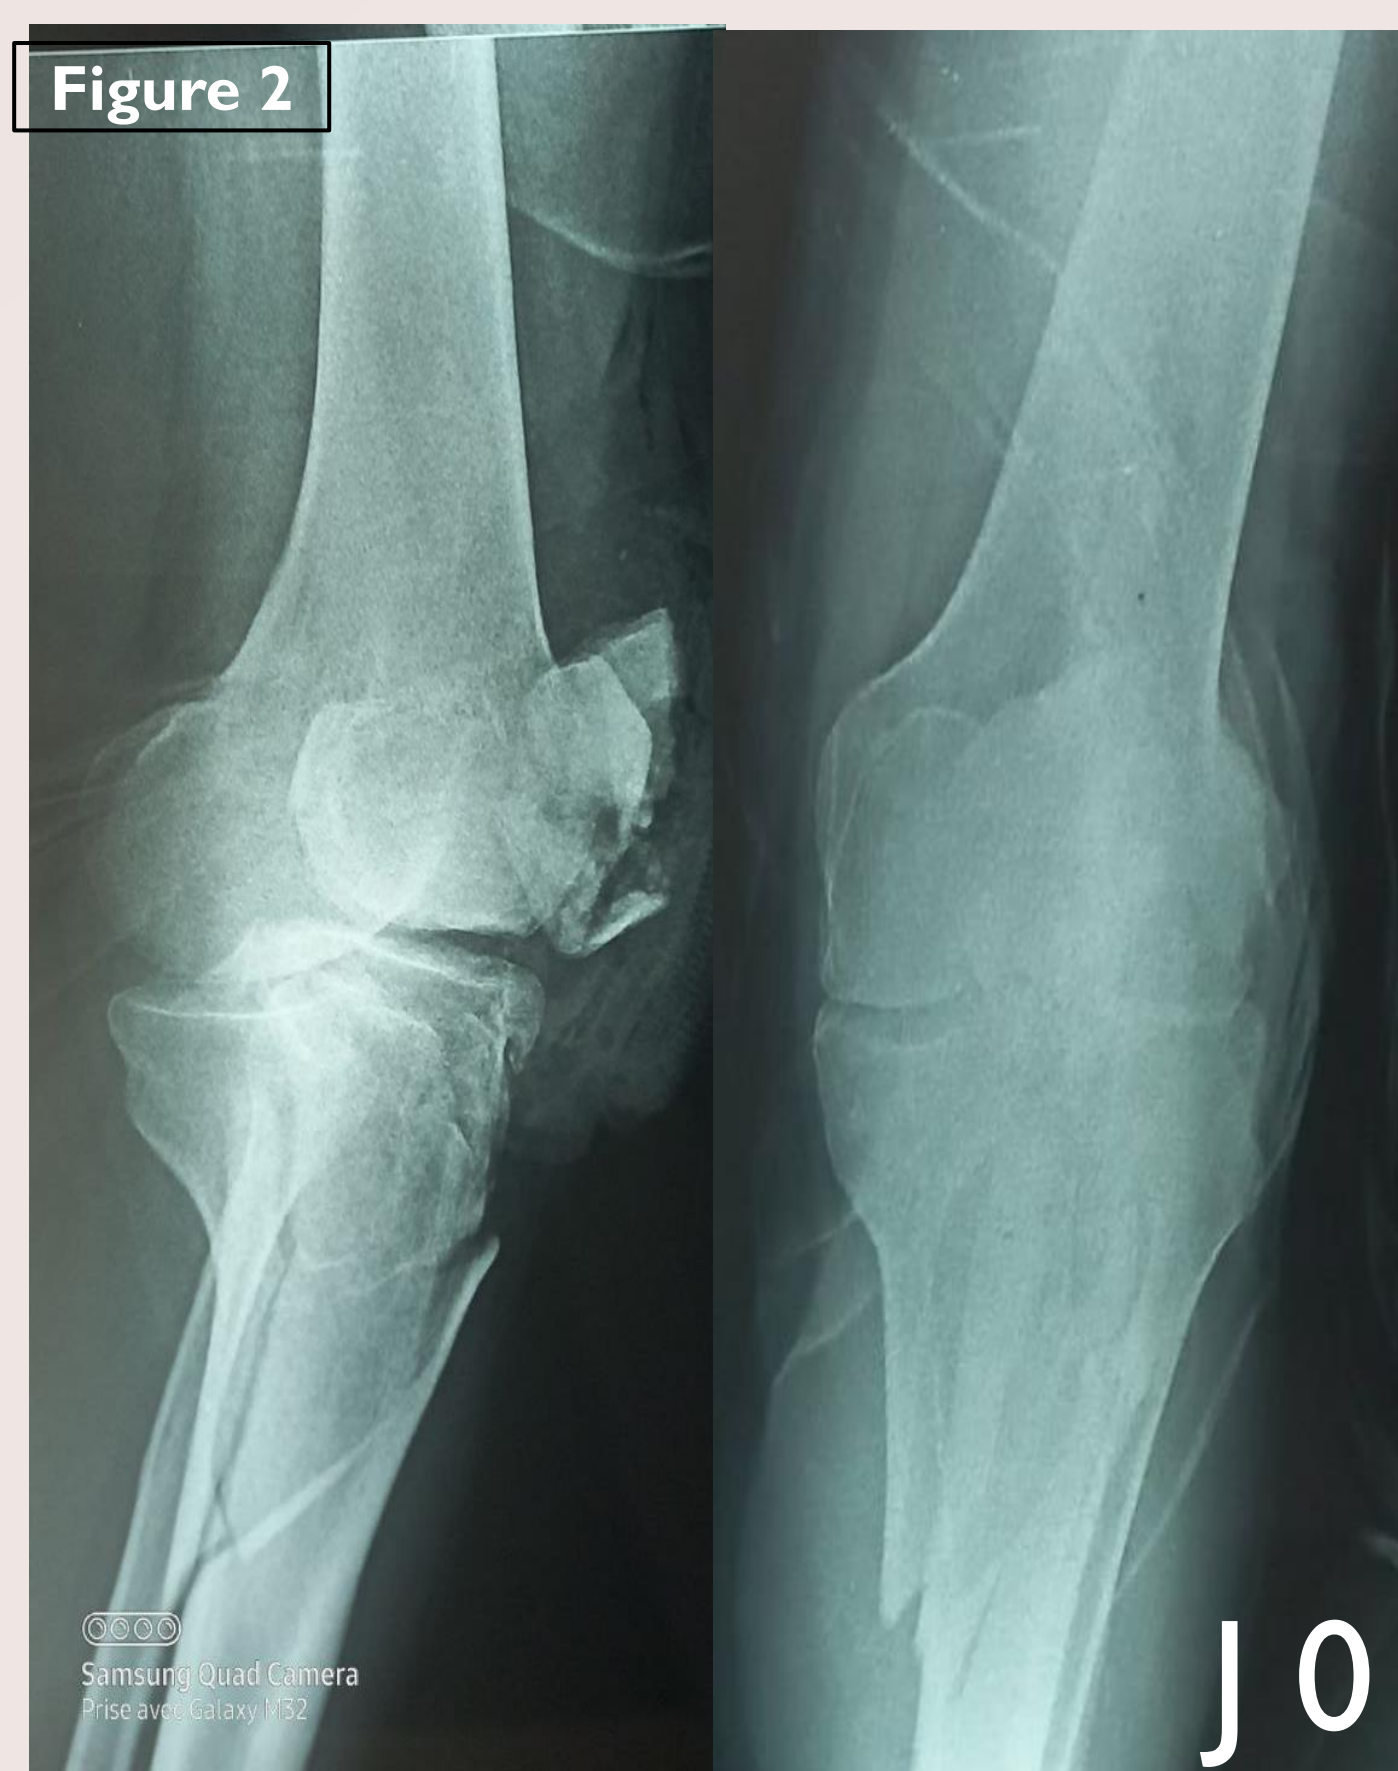
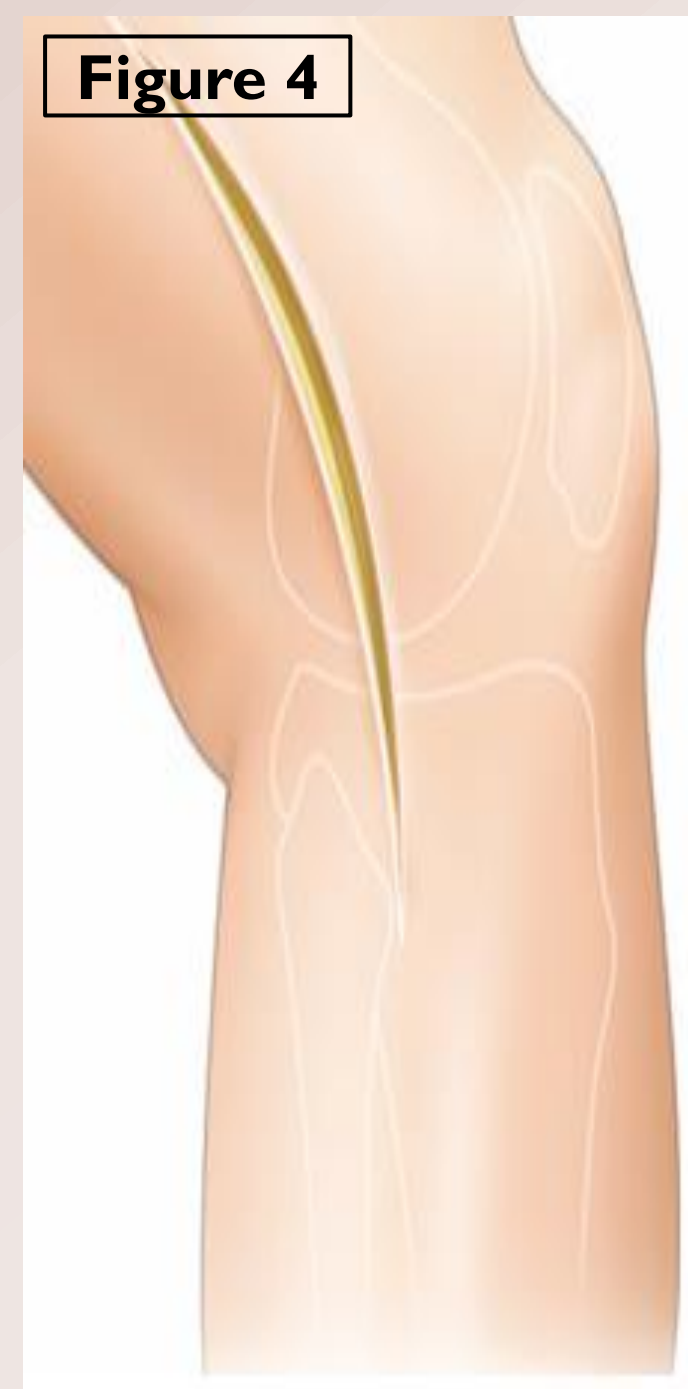
The patient presented with a closed knee trauma with no vasculonervous complications. Imaging showed patellar fracture BII according to MOULAY and RICARD, a lateral femoral condyle fracture B1 according to AO, and a tibial tuberosities fracture SCHATZKER type VI (fig 1,2,3) ; witch corressponds to type IIIB according to modified FRASER classification of floating knee. Surgical treatment used a lateral parapatellar approach (fig4) for sequential fixation of the lateral femoral condyle with screws then tibial tuberosities with an L inversed plate and then the patella with a tension band wiring (fig 5,6) .At the 10-month follow-up, radiological union was observed for all fractures (fig7). He achieved 81 according to the IKDC score witch is a good functional outcome (fig 8,9). The patient declare being satisfied with the result and went back to work .
